23 Squadron SPADs

From the Arthur W. Keen Collection

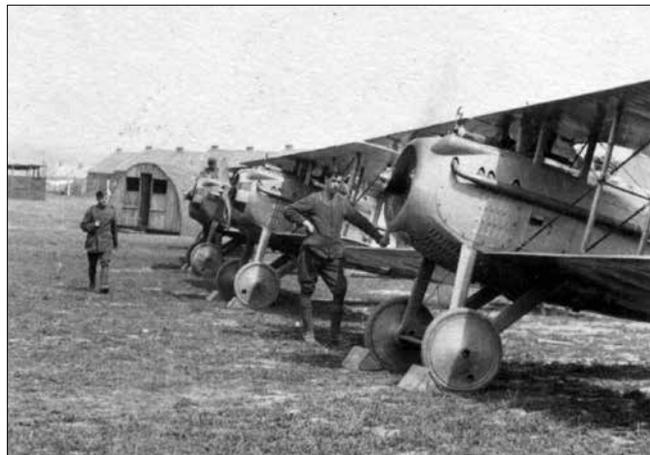
Above: Three 23 Sqn SPAD S.VIIs, probably photographed at Bruay. All appear to have been standard machines and the second and third carried the striped marking on their radiator shells that appears to have been a flight marking.

Among the Keen photos was this small selection showing SPAD S.VIIs of 23 Squadron. Any previously unpublished photograph of a WWI aeroplane deserves reproduction in this journal but these are also warranted because they clearly show two modifications made to the basic SPAD S.VII airframe – one obviously made at unit level, the other probably at the factory.

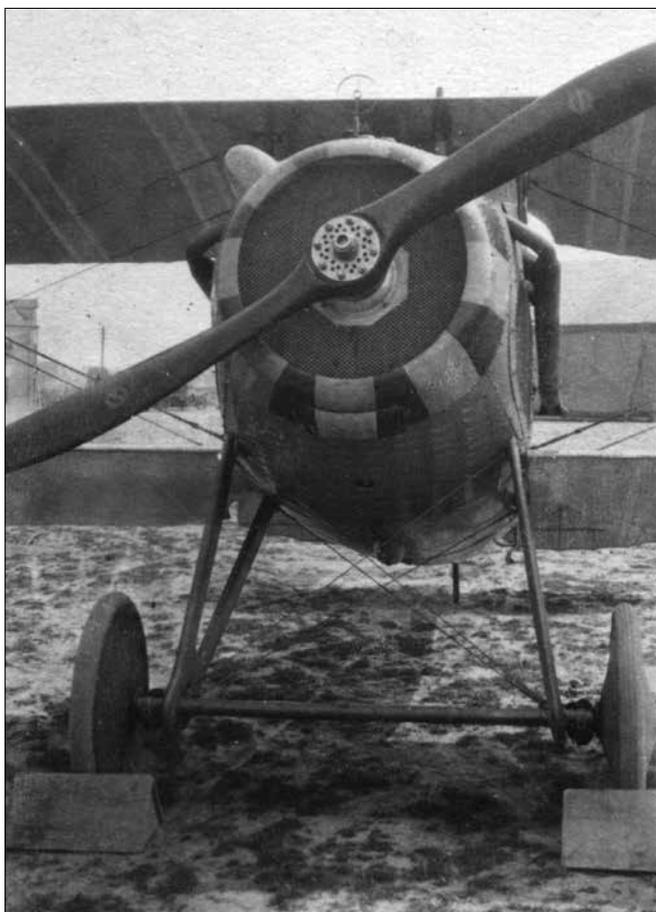
Below: Early SPADs had a tendency to shed wing fabric in steep dives, a consequence of the fabric 'ballooning'. This was alleviated through the introduction of two modifications: the covering of the leading edges, as far aft as the front spars, with plywood and stitching, rather than tacking, the fabric to the wing ribs. These two photographs, below, suggest that the stitching was to alternate ribs in each mainplane. The rib tapes appear to have been much wider than those usually seen on machines in British service. The machine in the rear view carried a flight (or deputy flight) leader's streamer on its rudder and appears to have been fitted with a rear view mirror.
