DUAL-CONTROL CAMELS A PHOTOGRAPHIC STUDY

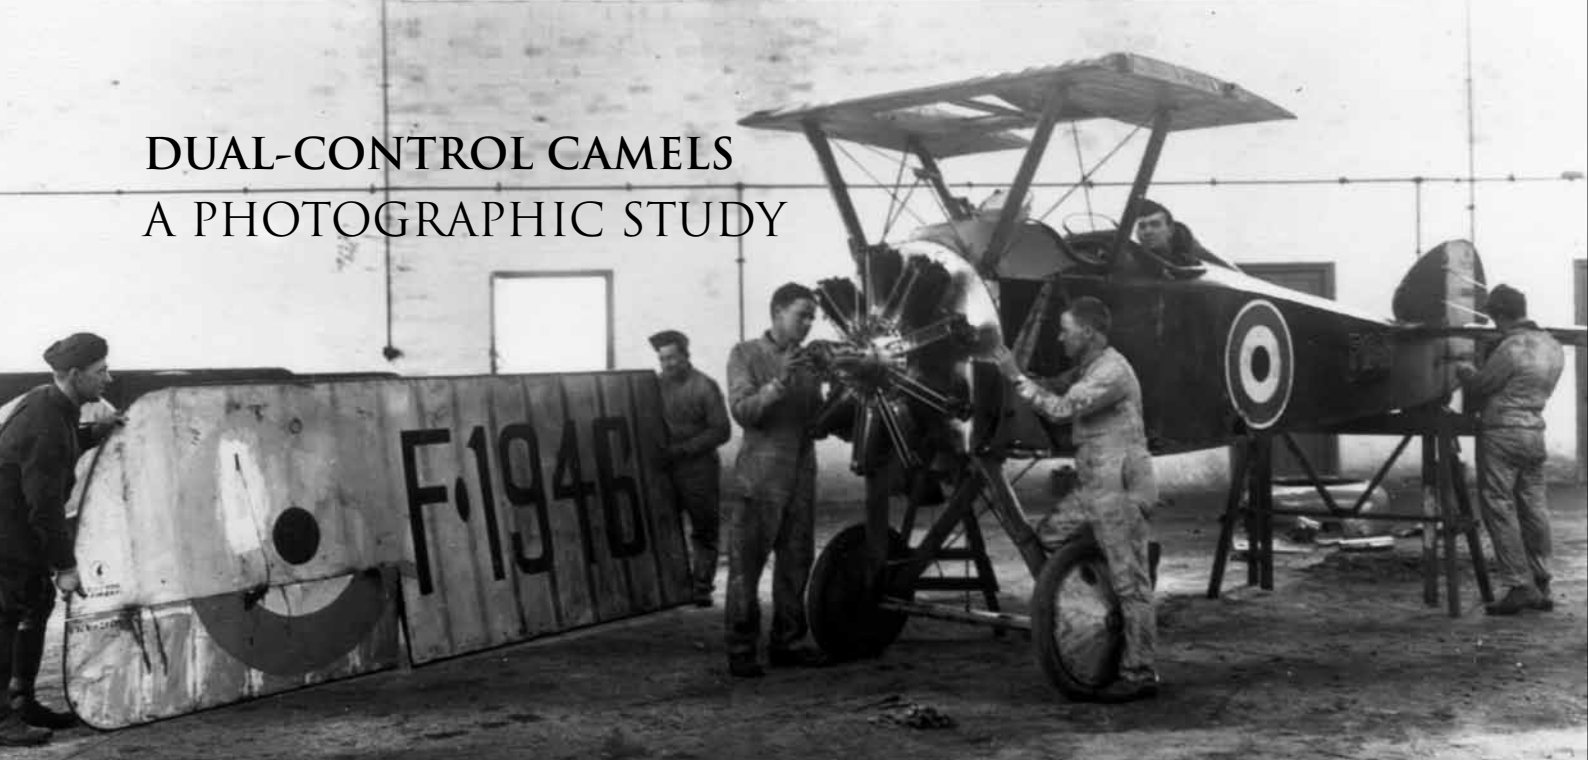
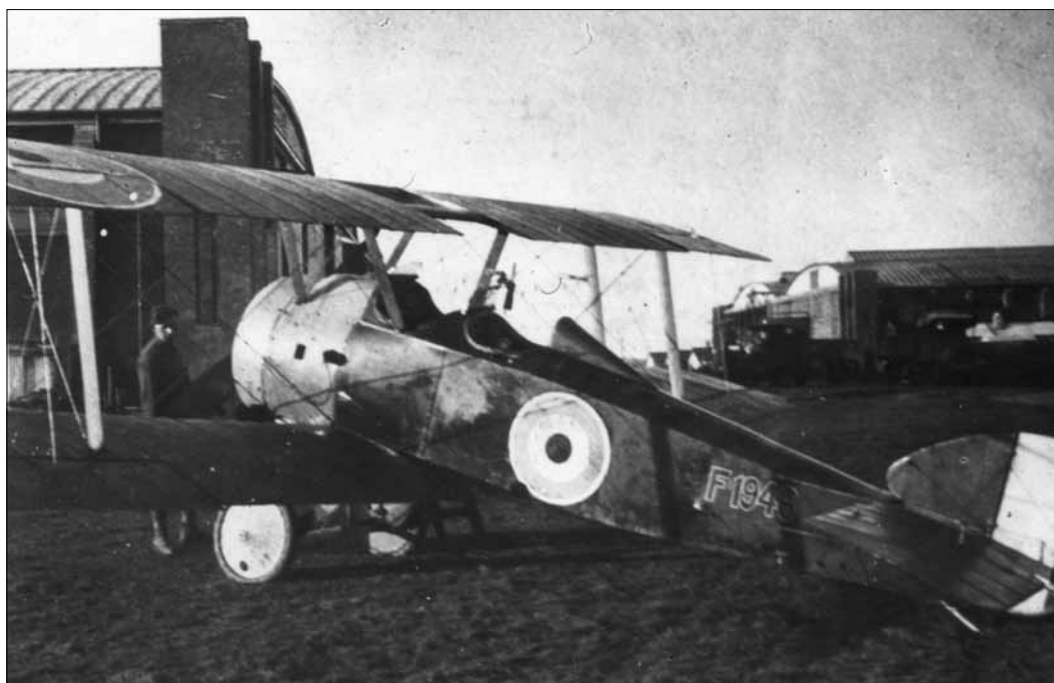
*F1946 of 5 TS AFC is shown under erection or repair in the header photograph. That at the right shows it fully assembled and reveals that, as with such machines converted at Montrose, its induction pipe was not raised. F1946, a converted Boulton & Paul machine, had enlarged cut-outs in its centre-section.
:CCI Archive*

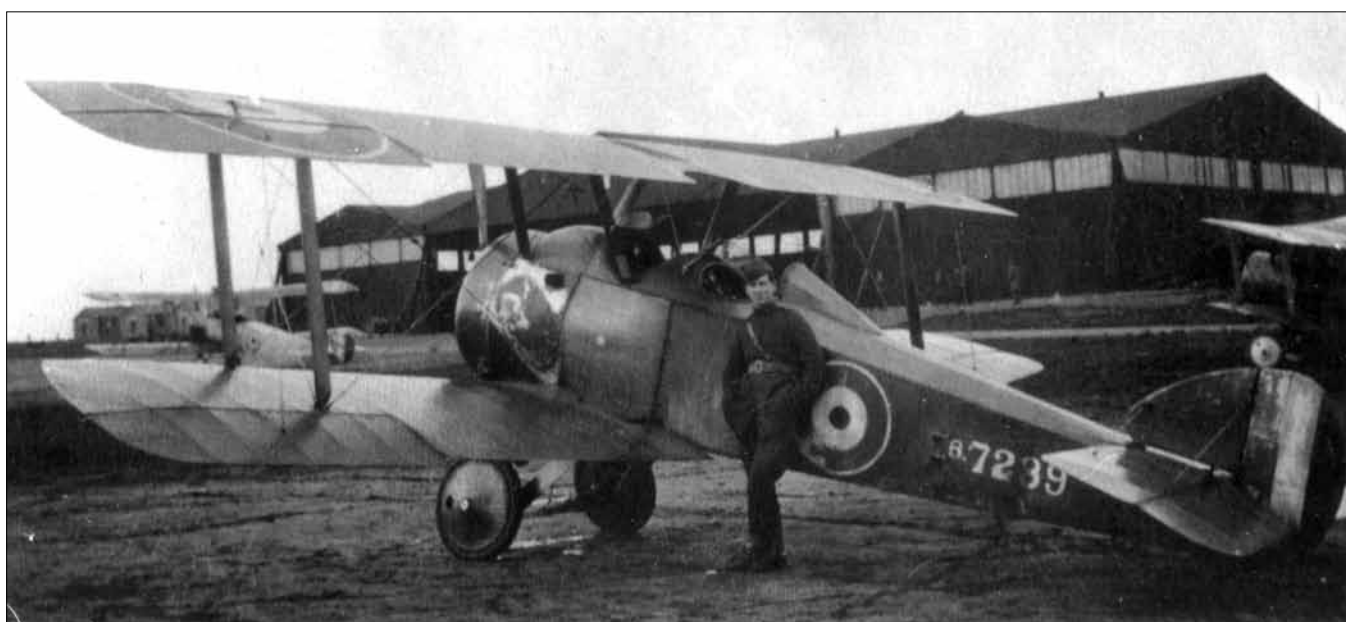
*B7239 of 56 TDS at Cranwell conformed more closely to the original conversion but had only a single pitot head.
:CCI Archive*
